**THE FAILURES OF THE MARS CLIMATE ORBITER AND MARS  
POLAR LANDER: A PERSPECTIVE FROM THE PEOPLE  
INVOLVED**

**Edward A. Euler and Steven D. Jolly**  
**Lockheed Martin Astronautics Operations Denver, CO**  
**H. H. 'Lad' Curtis**  
**ITN Energy Systems Littleton, CO**

**24th ANNUAL AAS GUIDANCE AND CONTROL CONFERENCE**

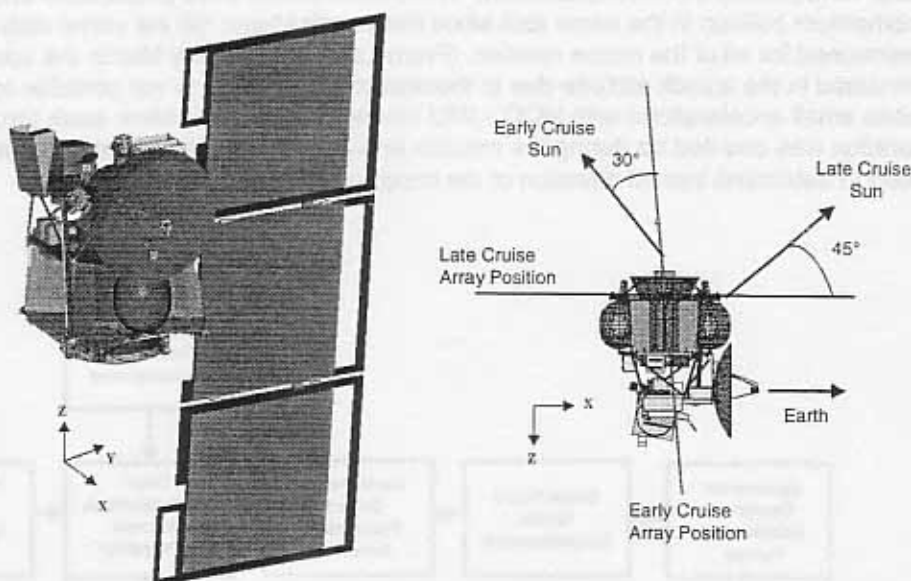
**Figure 1. MCO Cruise Configuration**

The orbiter cruise configuration is shown in Figure 1. The solar array (SA) is deployed, while the high gain antenna (HGA) remains stowed until after mapping orbit is achieved. During cruise the orbiter was flown with the SA offpointed from the sunline by approximately  $60^\circ$ , the inner gimbal is set at approximately  $-41^\circ$ , outer gimbal is set to  $0^\circ$ . During the first 15-20 days following Launch, the spacecraft body was rotated about the Y axis by  $14^\circ$  to shade the Star Cameras. The Orbiter essentially cruised in an orientation very similar to the safe mode orientation so when in safe mode the only difference was that the solar array is placed normal to the sun line. During late cruise the HGA was pointed at the Earth and the solar array offpoint was fixed at  $45^\circ$ . The SA was articulated into a passive restraint for TCMs and MOI in order to maximize control

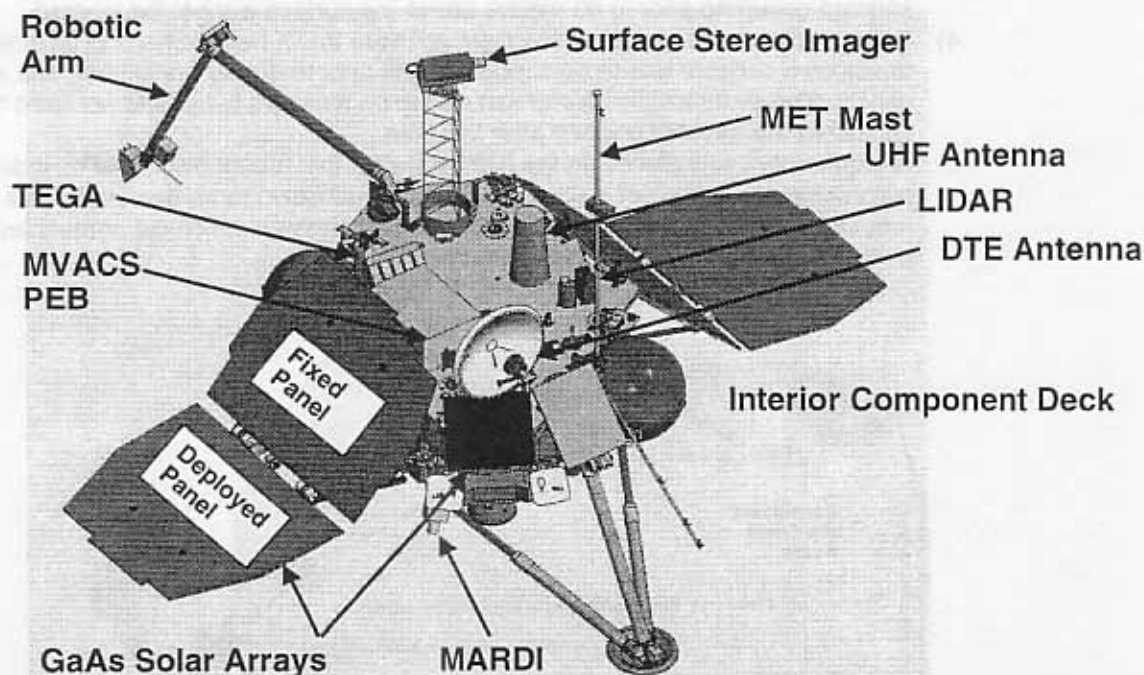
**Figure 6. Mars Polar Lander**

On December 3, 1999 at 1:20 p.m. MST Mars Polar Lander (MPL), Figure 6, sent its last transmission to Earth and turned away to orient for entry into the Martian atmosphere. That was the last confirmed signal from the spacecraft. After several months of attempts to contact the Lander the mission was declared a loss. What happened to the spacecraft? There is no certain cause of the loss of the vehicle and no hint of any anomalies prior to the last transmission. Post-mission failure boards identified six plausible failure modes including landing in hazardous terrain consisting of a steep slope near the predicted touchdown site (see Table 2). Although it will probably never be known absolutely what caused the failure of the only soft-lander since the Viking missions of the late 1970's there did emerge a most-probable cause of the failure.

On January 18, 2000, six weeks after we last heard from MPL, an LMA engineer running a test sequence on the Mars 2001 Lander software accidentally stimulated a logic error in the software used to shut off the descent engines on touchdown. That same software was used on MPL and the discovery led LMA engineers to the most probable cause of the MPL failure: premature shutdown of the descent engines 40 meters above the surface of Mars. How had this logic error escaped detection over a period of two years of development, a year of spacecraft system testing, and the intensive pre - and post - landing review by hundreds of engineers? There is no single explanation, but to infer that the Faster-Better-Cheaper (FBC) project management approach was the cause, is too simplistic.
